INTRODUCTION The coastal cliffs along much of the central California coast are actively

The 0.9 km stretch of Seabright Beach extends from San Lorenzo Point on the reaching the shoreline in northern Monterey Bay are commonly storm waves west to the Santa Cruz Yacht Harbor on the east (figs. 1 and 2). The cliffs at Seabright approaching from the southwest to west. Beach are completely protected from wave attack by a wide beach. The protective beach is a relatively recent feature that formed after the emplacement of the Santa Cruz Yacht highest high water is 2.4 m and the lowest low is -0.8 m (U.S. Army Corps of Harbor jetty in 1963-1964. Prior to the completion of the jetty, the cliffs at Seabright Beach Engineers, 1985). The highest monthly tides occur in the winter and summer; it were subject to daily wave attack. The data in this study are post-jetty construction; therefore, the seacliff failures and cliff retreat are the result of nonmarine processes (rainfall, groundwater and seismic shaking).

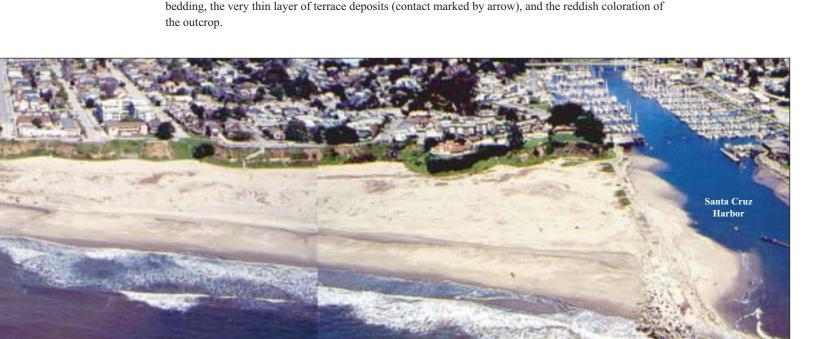
Figure 4. This oblique aerial photomosaic of Seabright Beach shows the layout of the beach with respect to San Lorenzo River and San Lorenzo Point to the west and the Santa Cruz Harbor Jetty to the east. The cliffs here range from 8 to 15 m and are highest near the Point. The accompanying equal-area stereonet plots of joints measured along the cliff face show a variation in joint orientations and joint sets along the back beach cliff and San Lorenzo point. The stereonet labeled A shows those joints mapped only along the north-south oriented San Lorenzo Point. In this representation, it can be seen that there are three primary joint sets. Two of these are near vertial and oriented NW and N-S; a nearly horizontal set strikes NNE. The stereonet labeled B shows those joints located along the 900-meter east-west stretch of cliff. The two primary joint sets measured along this section of cliff are oriented

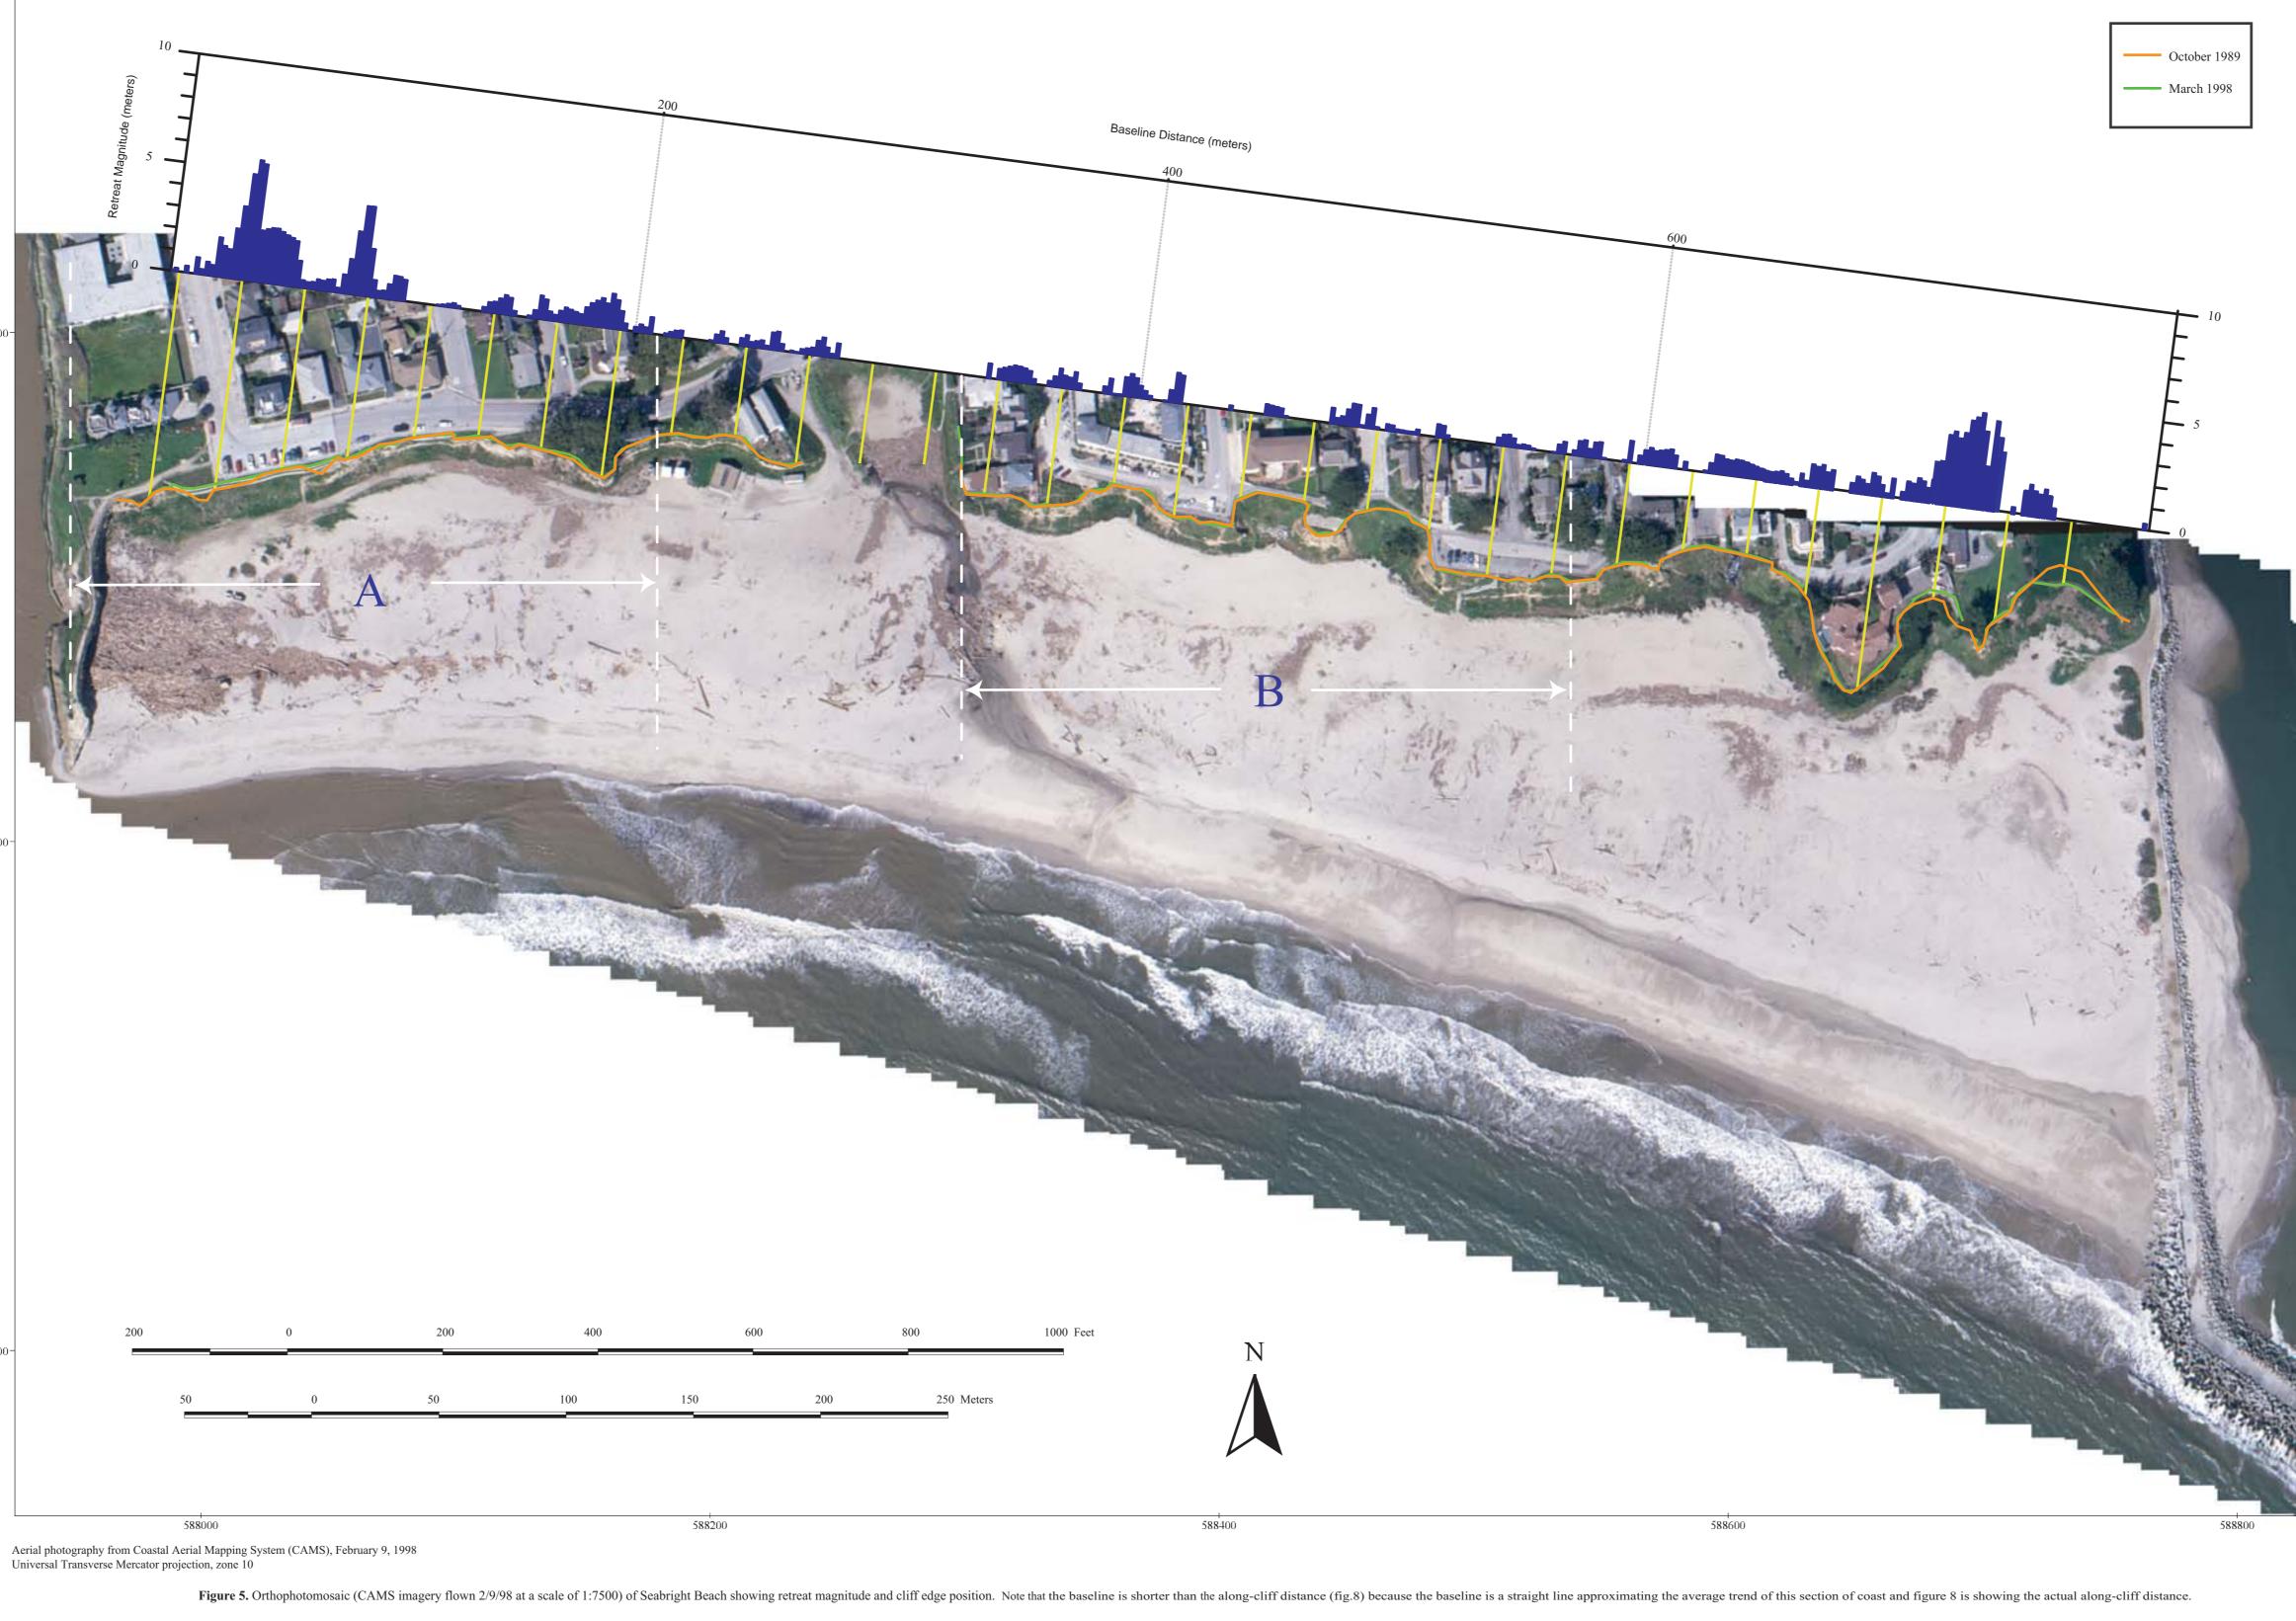
Aerial photography from Coastal Aerial Mapping System (CAMS), February 9, 1998 Universal Transverse Mercator projection, zone 10 Figure 6a. Enlarged section of the western portion of orthophoto mosaic (fig. 5, A) showing failure signatures for four time periods.

previous failures. Figure 6a shows that a 75 m length of cliff failed during the decade from 1989 to 1998 (red line). A retaining wall was built in this location and has impeded the retreat of the cliff since its construction. The cliff, as a result, did remain stable during the 1997-98 El Niño storms, although slope failures during these storms were documented slightly east of the retaining wall along a 55-m-long section (fig. 6a, blue and green lines). Another area of cliff failure is shown in figure 6b, an enlargement of area B in figure 5. The cliffs in this area failed in a similar manner during the Loma Prieta earthquake and the 1997-98 El Niño. There was no significant retreat (< 1 m) documented during any specific time interval. Recent scars and deposits identified from the rectified photographic stereo models show that the linear geomorphic expression of each individual failure is small (4 to 10 m) even though the cliff did fail along much of the length shown in figure 6b. Failures commonly occur on the face of the cliff, undercutting the asphalt of overlying roads and parking lots, but result in no measurable retreat of the top edge of the cliff. In general, the overall distribution of seacliff failures along the Seabright Beach section reveals widespread slope failure characterized by many small linear failures on the slope face. A more continuous style of failure occurs in the west half of the cliff section where the majority of the cliff is composed of the Purisima Formation. The smaller failures occur primarily where the cliff is predominantly composed of terrace deposits.

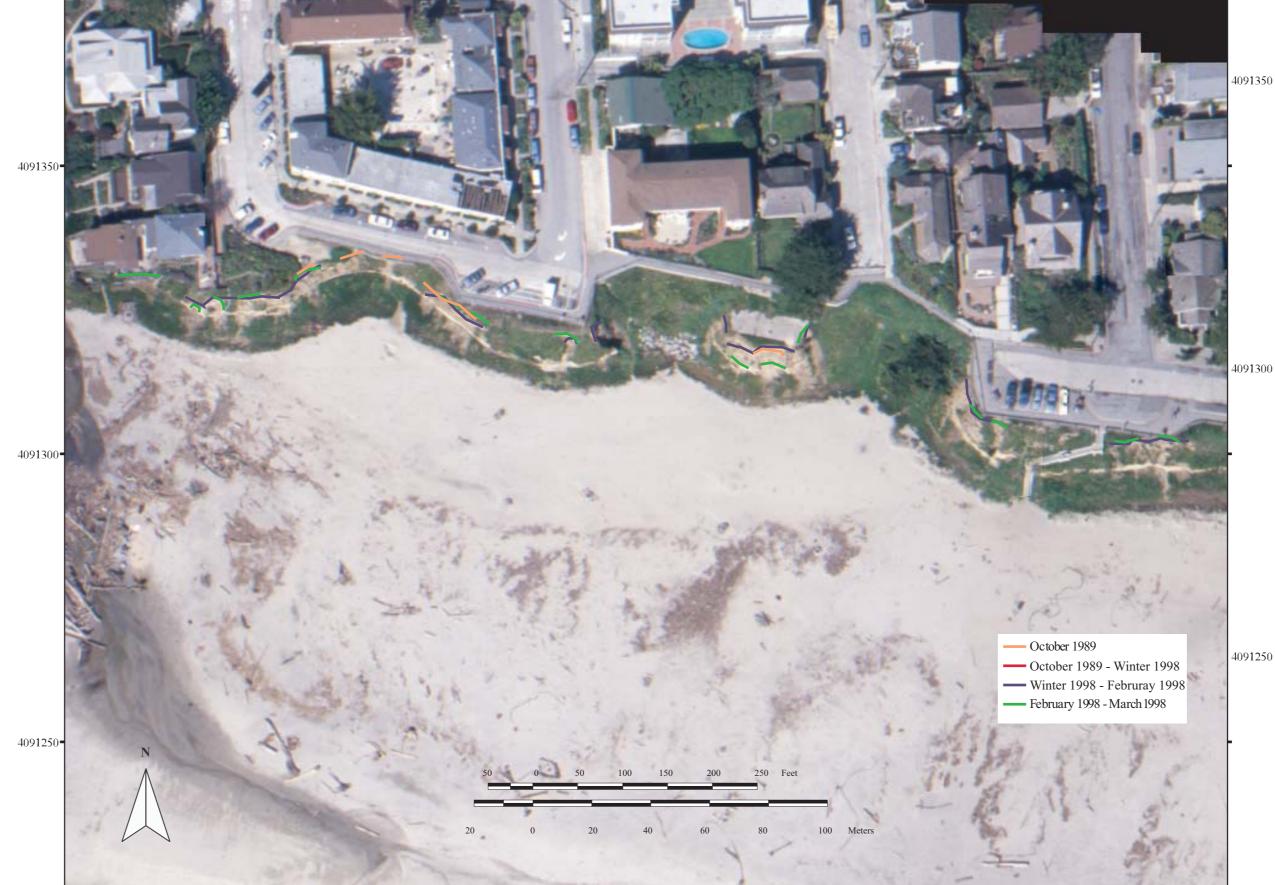
Figure 6b. Enlarged section of the eastern portion of orthophotomosaic (fig. 5, B) showing failure signatures for four time periods.

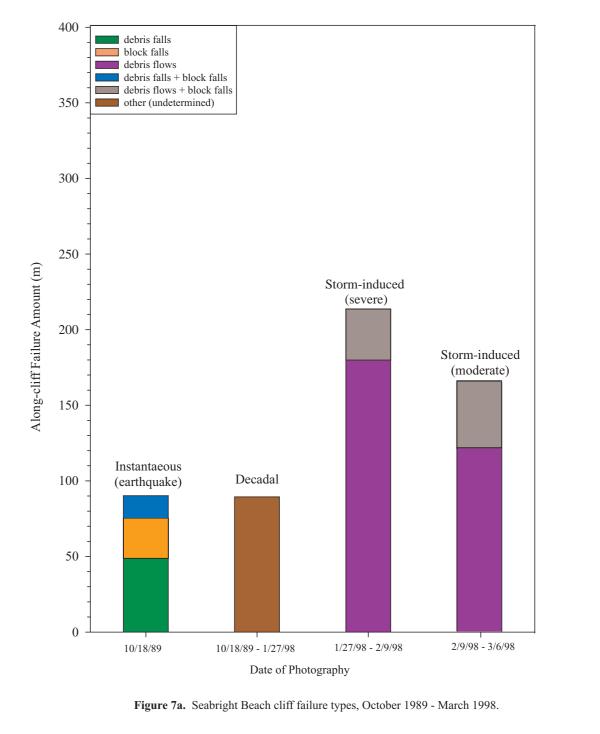
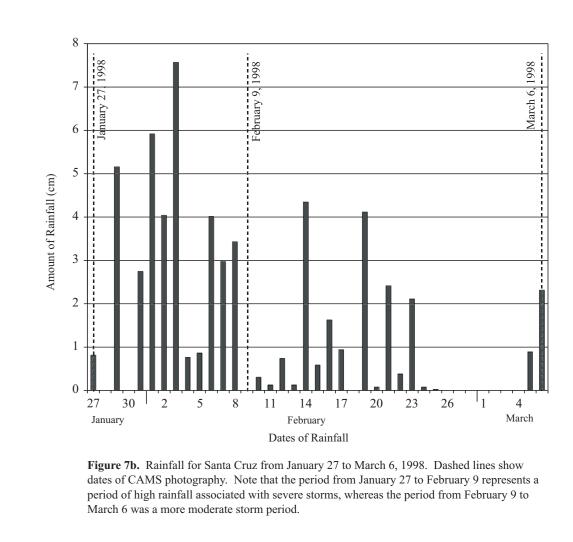
Types of cliff failures Tp failures △ January 1998 to February 1998 — Mixed failures February 1998 to March 1998

Figures 7 and 8 and table 1 summarize the overall failure styles, retreat amounts, slope failure distribution, and rainfall amounts along Seabright Beach. In figure 7a, the failure types are shown in relation to the time of occurrence and the amount of the section that failed, and Table 1 shows the total amount of cliff failure for each time interval as well as the

failure types. Table 1 also includes the geologic unit that failed, if this was distinguishable on the aerial photography. The category labeled "other" represents decadal slope failures wherein cliff retreat was documented but the failure style could not be discerned. Three different types of slope failure were documented during the period from October 18, 1989 to March 6, 1998. These include debris falls, block falls, and debris flows. Rapid, seismically induced failures were either Survey Open File Report 77-718, 347 pp. block or debris falls, resulting in failure of 90 m of the 0.9 km-long cliff Griggs, G.B., and Johnson, R.E., 1979, Coastal Erosion, Santa Cruz result of seismic shaking may have contributed to the failure of the cliffs in the decade since the Loma Prieta earthquake, in which 89 m of the cliff experienced some failure and resulted in significant retreat of the cliff edge in two locations. In some areas, the process of failure could not be identified due to lack of a geomorphic scar or a characteristic toe deposit. These areas were identified by a retreat of the cliff edge and are included as "other" in table 1, whereby the cliff retreated but the process was not interpretable. The 89 m of decadal failures were all included in this "other" category. The dominant failure type documented from the February 1998 imagery is debris flows of the terrace deposits. The period of severe storms in the several weeks prior to February 9, 1998, had the greatest impact on this stretch of coast. Over 213 m of the cliff failed during this period, predominantly by the process of debris flows involving the terrace deposits. During the last several weeks of the El Niño storm period, precipitation amounts dropped and storm intensities decreased (fig 7b). The response of the seacliffs during this time was still significant; failures were documented along 165 m of the section. Debris flows and minor block falls were the two types of failures identified during this period. Figure 8 is a plot of the distribution and amount of cliff failure

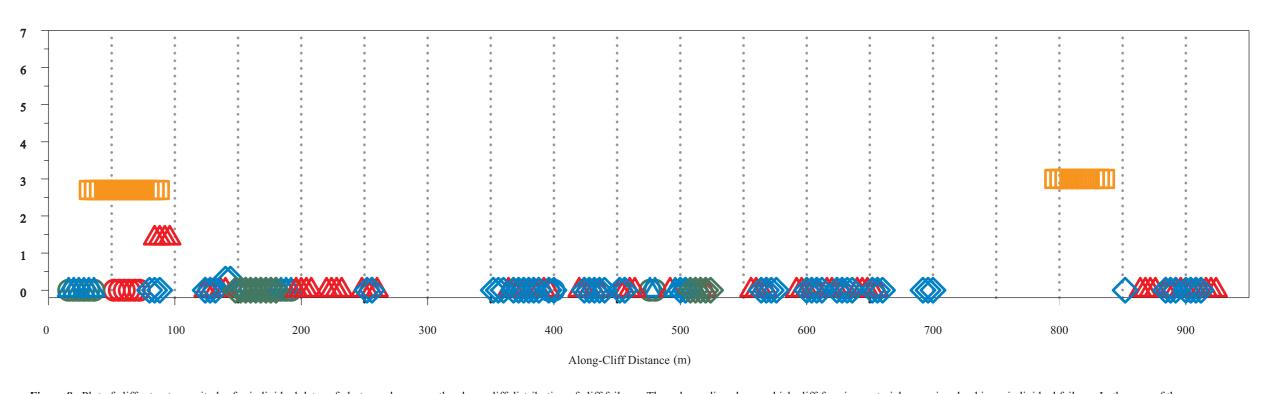
Figure 8. Plot of cliff retreat magnitudes for individual dates of photography versus the along-cliff distribution of cliff failures. The color coding shows which cliff-forming materials were involved in an individual failure. In the case of the area near the beginning of the section (between 0 m and 50 m), cliff failure was identifed in the October 1989 photography as failure involving a mixture of the Purisima Formation and the terrace deposits. This is represented by the green circles. Note that all "retreat" values for the October 1989 date of photography are shown as zero. This date was used as the baseline data, and thus no other data set currently exists against which to determine the amount of retreat for this date. However, along-cliff failures are identified by deposits on the beach and scars on the cliff slope. The along-cliff distance is longer than the baseline shown in figure 5 because the baseline is a straight line approximating the average trend of this section of coast and figure 8 is showing the actual along-cliff distance.

along Seabright Beach. The along-cliff distance in figure 8 is longer than the baseline shown in figure 5 because the baseline is a straight line approximating the average trend of this section of coast and figure 8 is showing the actual along-cliff distance. All failures documented from October 1989 are shown as having zero retreat amounts. The amount of landward retreat of the cliff edge is not shown for the October 1989 date in figure 8 because the cliff position delineated from this date of photography was used as the initial position against which to measure subsequent retreat. Failure types can be recognized by geomorphic scars or toe deposits, but retreat amounts cannot be documented. Figure 8 demonstrates the nearly continuous occurrence of failures with a small amount of retreat occurring at two distinct locations. The area that was retreating in the western portion has now been stabilized with a retaining wall and consequently did not fail during the 1997-98 El Niño. The amounts of retreat on figure 8 are for each individual time period, whereas those shown on the bar graph on figure 7a are cumulative. The amount of failure of the terrace deposits (blue on fig. 8) is much more widespread than those within the Purisima Formation (red), and most of the documented slope failures resulted in no measurable retreat of the cliff edge. However, the pervasiveness of the slope-face failures causes a steepening of the cliff face which may result in a less stable slope prone to future failures. This map has introduced new techniques of analyzing the shortterm evolution of seacliffs and the differential response of seacliffs to seismic and climatic events. Using stereo models derived from softcopy photogrammetry, we are able to locate seacliff failures to determine their spatial distribution and the geologic units involved for several different time periods in an area where seacliff failure and retreat periodically threaten homes and community infrastructures. These data can be incorporated into a GIS database to examine the relationship of the failures to one another, to coastline morphology, and to field data (faults, joints, or lithologic changes). Spatial plots of the failures appear to show specific patterns; if additional data continue to support this observation, the technique of analyzing the temporal and spatial distributions of the cliff failures outlined in this study may help to identify areas prone to future failures.
